Green Island Ice Arena ROM Report

CITY OF LA CROSSE, WI
NOVEMBER 2019

Green Island Ice Arena - ROM

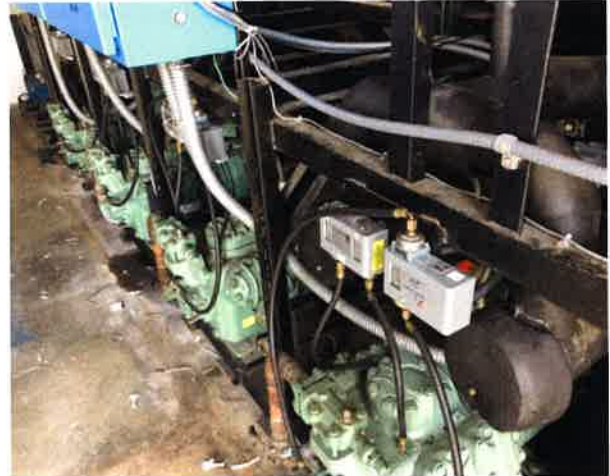
Ice rink refrigeration is provided by an R507 based plant using 4 compressors in an indirect configuration. The plant is approaching end of useful life, and it was discussed that the chiller plant may have been previously used when it was installed. A heat recovery system serves the snow melt pit and subfloor heating loops; snow melt pit operation is considered problematic as ice shavings build up after multiple resurfacing sessions. The exterior condensing unit was replaced in 2012 and appears to be in satisfactory condition. Winter operation typically requires 1-2 compressors while summer operation can require 3-4 compressors at times. It was discussed that the electrical circuit serving the chiller plant occasionally trips on over-current protection when 4 compressors are running; this indicates that electrical service upgrade may be required for proper and safe operation.

The concrete arena floor and associated piping loops have not presented problems to this point; leaks have not been detected and a survey indicated that surfaces are generally level.

Replacement of the compressor plant should be considered within the next several years. R507 refrigerant is subject to the Montreal Protocol which may result in limited future supply and increased cost. After-market R507 supplies are expected to last for the foreseeable future, however price volatility remains unpredictable. The indirect configuration of the system means that refrigerant is generally contained within the mechanical room, thereby reducing the total amount of R507 to an estimated 600-1000 pounds. While significantly less than the amount of refrigerant contained in a direct system (6000+ pounds) there is still an unpredictable financial risk should the system suffer a leak. A well maintained R507 system can have a lifespan exceeding 20 years, however, planning for future replacement is recommended to ensure long term stability of the operation. Multiple options and considerations for plant replacement are listed below:

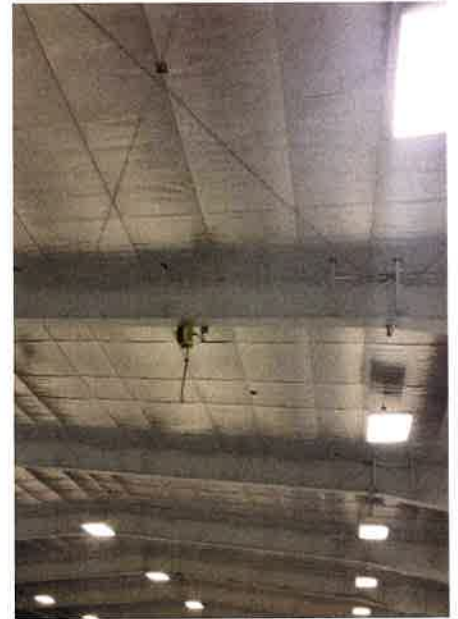
Fluorescent fixtures are present throughout the facility. 12 lamp T5 fixtures provide lighting for the ice arena with limited switching control. Remaining areas are a mix of linear fluorescent and compact fluorescent fixtures. One row of LED linear fixtures are present near the north end of the facility.

It was discussed that a two phased lighting retrofit may be desired in order to quickly improve aesthetics and occupant experience in the facility. Based on information provided to the City by local vendors the following approach can be pursued:

- Retrofit "non-ice sheet" fixtures including entryway, lobby, concessions, restrooms, locker rooms, and spectator areas. This work could be accelerated for completion in 2019. Energy savings could be captured and utilized for subsequent facility enhancements.
- Retrofit remaining "ice sheet" fixtures in conjunction with subsequent project. Fixtures can be replaced on a "one for one" basis in accordance with current proposals or evaluated further for increased fixture density.
- Lighting controls, including switch locations, can be improved in conjunction with retrofits.

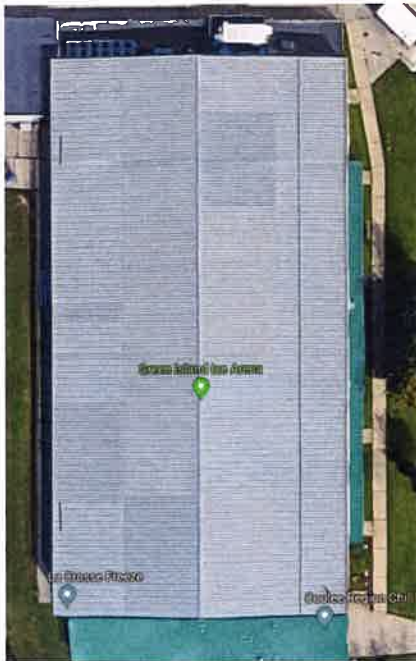
Several areas of the building exterior were replaced/repared after a tornado in 2012. The steel roof was left in place and is now approaching end of useful life.

Infill and overlay of the existing steel roof is recommended to provide a cost-effective and long lasting solution for the facility. Two inches of flute fill insulation and two inches of rigid polyisocyanurate insulation will be fastened on top of the existing steel roof and covered with a fully adhered 60 mil EPDM membrane. The new insulation layers will provide an approximate R value of 22. Analysis of the original building drawings indicate that existing insulation values could be as high as R15; actual insulation values can be determined by removing minor sections or accessing through vent penetrations.

This solution will provide significantly improved insulation values and vapor barrier characteristics with a life expectancy exceeding 20 years.

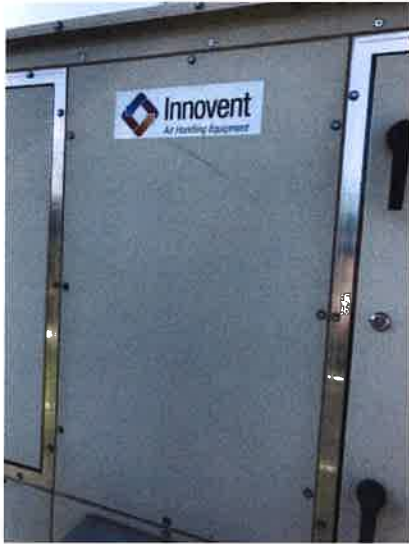
HVAC equipment throughout the facility appears to operate in fair to poor condition; equipment is generally functional however most units are approaching end of expected useful life. Replacement of major HVAC equipment should be considered in the near future.

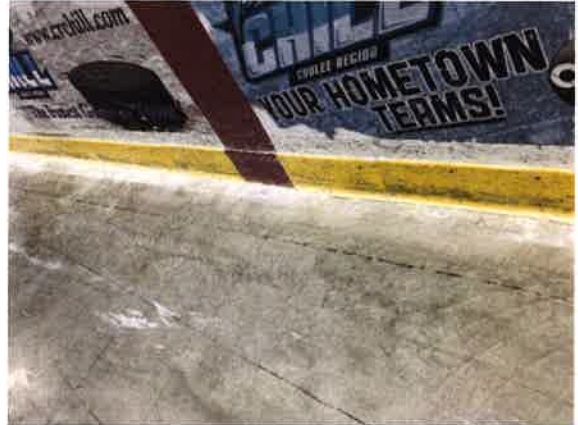
The dasher board & glass system contains a mix of components from several different manufacturers including Becker, Athletica, and possibly Cascadia. Stanchions in several locations protrude into the playing area more than typical arenas resulting in unpredictable puck deflections. Overall condition of components is considered fair to poor.

Rubber flooring is present throughout the arena. Flooring components are approaching end of expected useful life in most locations.

- (1) Replace entire dasher board & glass system with Becker Signature Series (or similar), scope of work to include:
 - Galvanized steel frame dasher boards with high-density polyethylene dasher facing and kick plates.

- (1) Replace rubber flooring throughout the arena, scope of work to included:
 - Approximately 9,200 square feet of 10mm 4' by 6' SportFloor Stamina rubber flooring with speckle finish in "public" areas. (includes 7% overage for stock).
 - Approximately 5,376 square feet of 10mm 4' by 6' SportFloor Stamina rubber flooring with basic finish in locker rooms and other miscellaneous spaces. (includes 7% overage for stock).

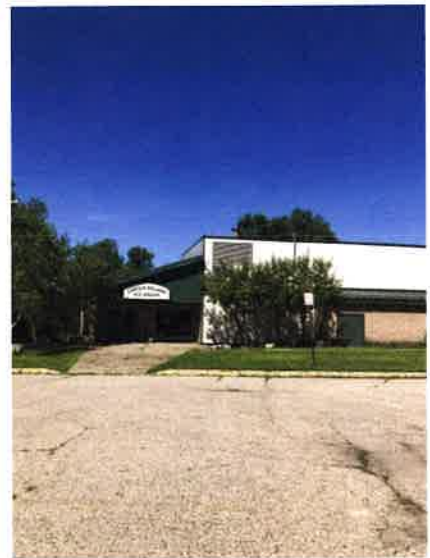
Exterior doors throughout the arena are in varied conditions. Weatherstripping appears degraded at most locations. Air and pest infiltration is likely occurring throughout the facility.

Replacement of exterior doors can be performed throughout the entire facility or at select locations. The following options exist at each location:

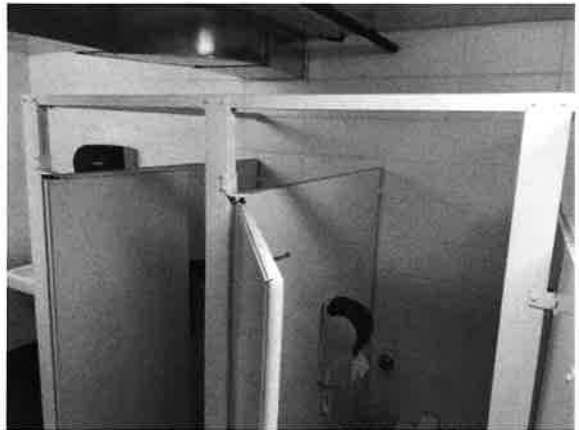
Restrooms are located on the south end of the building near the main entrance and on the north end of the building. Several additional restroom and/or shower areas are present within the locker rooms. A shower area was added to one of the locker rooms on the east side of the building; the shower does not appear to meet current codes.

Four locker rooms are located beneath the spectator seating area on the east side of the building. Two locker rooms, including one dedicated to the Chill, are located on the north side of the building.

- The “makeshift” shower in the east locker room requires additional modifications to meet codes. Since the locker room was not designed to have a shower area, it is recommended that the modifications be removed and the area restored to its previous configuration. If the shower area is desired/needed, the following modifications are recommended:

- Add floor drain in the area directly adjacent to existing showerheads. A trough style drain could be installed near the wall directly beneath the showerheads for optimal drainage; re-grading of the floor would be required. Alternatively, a single floor drain could be added several feet west of the showerheads; minor re-grading of the floor is likely required for this approach as well.

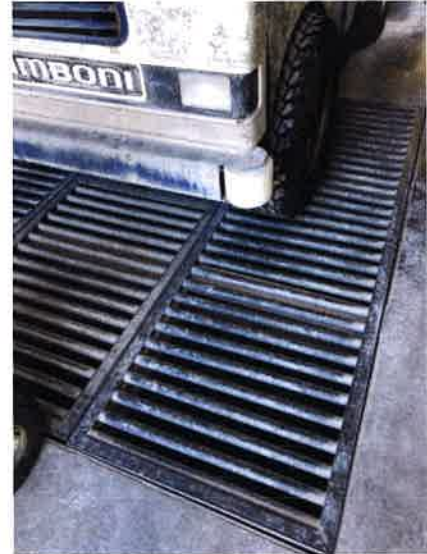
Domestic hot water is currently used to fill the resurfacer tank.

REALice is a device installed at the resurfacer fill station that enables operators to use cold water to resurface the ice. Energy savings are realized from the elimination of natural gas previously used to heat resurfacing water and from the reduced load on the compressor plant during resurfacing operations. Energy savings are dependent on the frequency of resurfacing, the facility operating season, and the efficiency of previously used water heating equipment.
